Electrical Distribution Safety

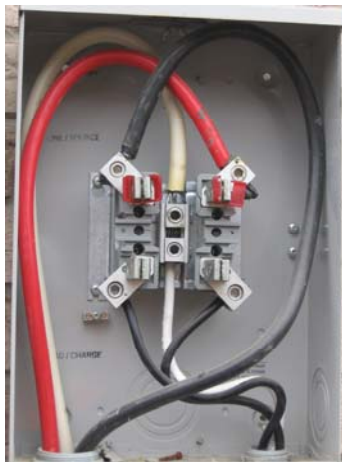
As a result of ESA's ongoing meter base failure analysis work, ESA (Regulatory - Code Staff) is assembling stakeholders. ESA, LDCs, manufacturers and equipment certification organizations will be involved in a coordinated approach to data collection and analysis. Meter base failures are occurring when the meter is removed from the meter base and the supply conductor short to the metal cover, due to the broken meter base. ESA is requesting LDCs provide information on failures in order to address the safety and reliability concerns faced by LDCs.
